Manhole Inspection Summary

Manhole # S09GG2010MH

Location Address: **6000 GREEN MEADOW PKWY** Cross Street: **WESTERN PARK DR**

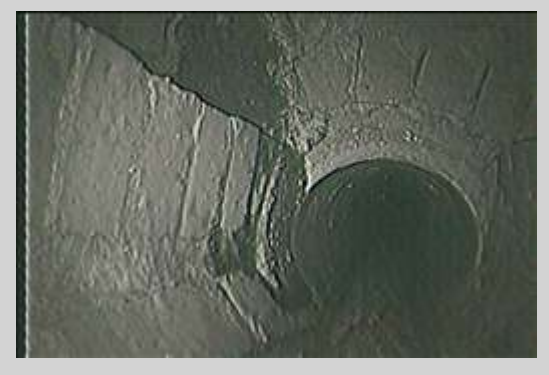
8 in. Circular Gravity Sewer Pipe Out @ 12 O'Clock

Rod and Bar (Angled)

Pipe Material: **Clay** ☐ Pipe Lined

Infiltration: **None** Pipe Seal Cond: **Unknown**
